Overview of Accident in Secondary Piping at Mihama Nuclear Power Plant, Unit 3

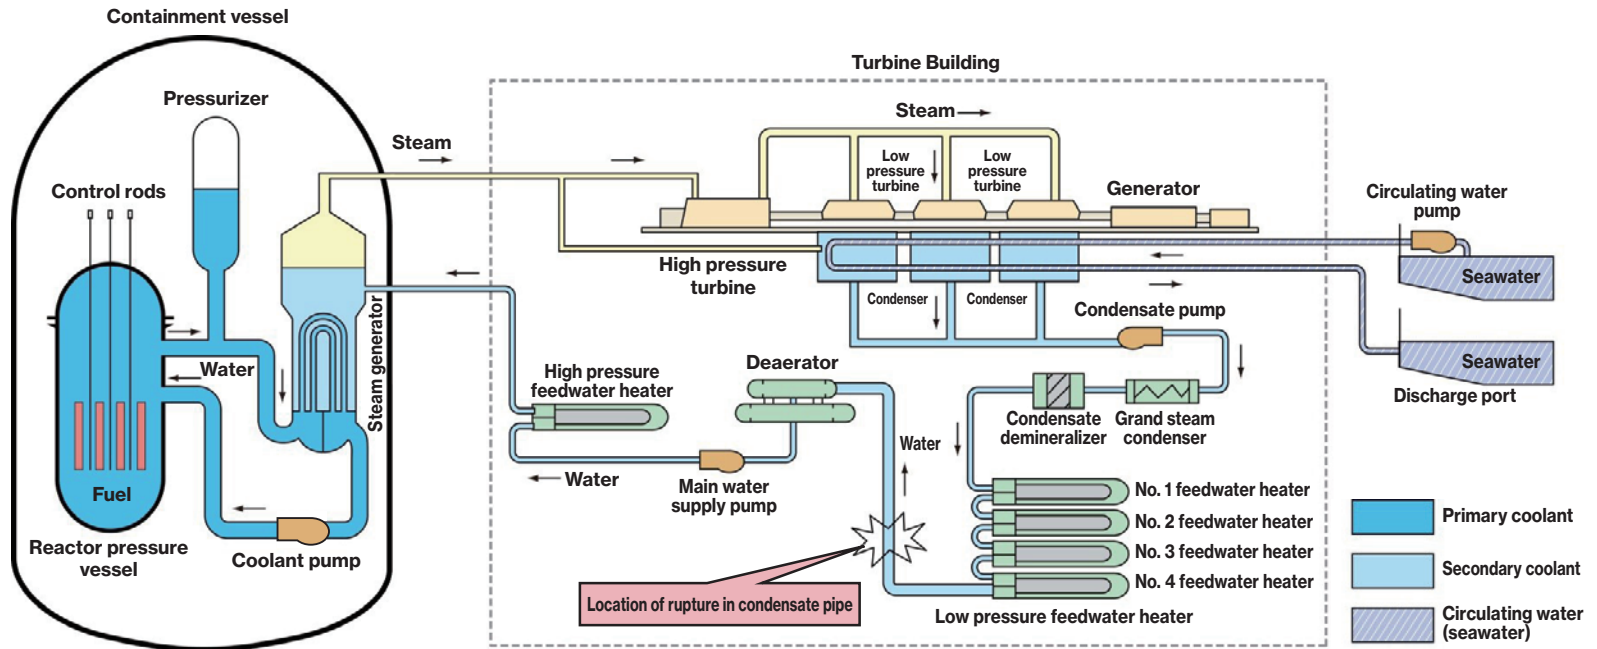
With the workers inside, a condensate pipe ruptured near the ceiling on the 2nd floor inside the building housing the turbine, causing hot water at 140°C and 9 atmospheres of pressure to blast out as steam.

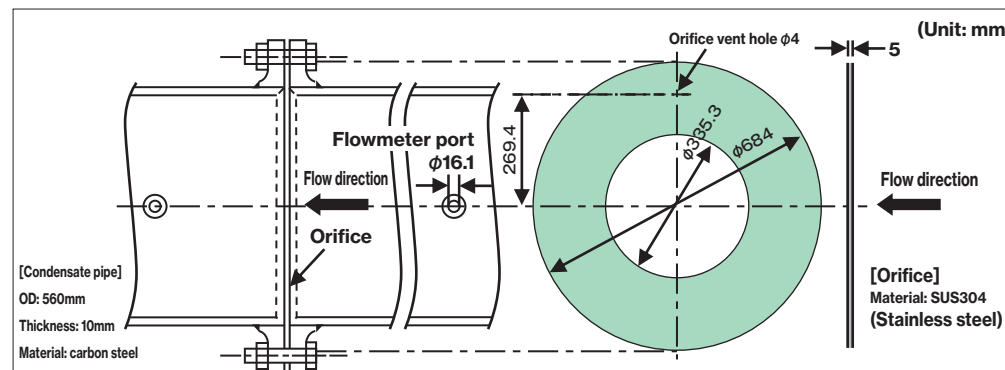
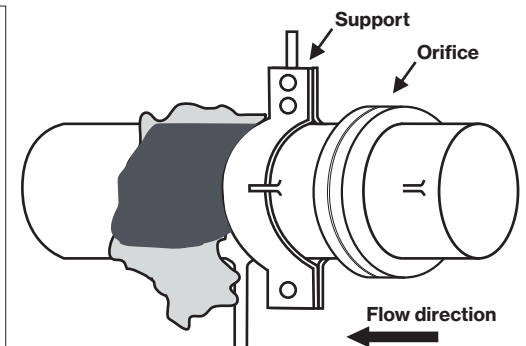
A large rupture was found downstream of an orifice (flowmeter) for measuring condensate pipe water flow.

The investigation found that turbulence was likely to occur at points downstream of the orifice and an internal inspection of the part that ruptured found that the so-called erosion-corrosion process had gradually reduced the thickness of the pipe, thus weakening it to the extent that it ruptured due to the load during operation at the time.

Management guidelines were established in 1990 for the wear of secondary piping in PWR, and from that time parts of pipes that were anticipated to be corroded had been measured according to plan. However, the part of the pipe that ruptured (A line) was from the very beginning supposed to be measured, but it had been missed and the thickness of the pipe had never been measured at the time of the accident.
