# Overview of Accident at Mihama Nuclear Power Plant, Unit 2

## ○ Overview of the accident

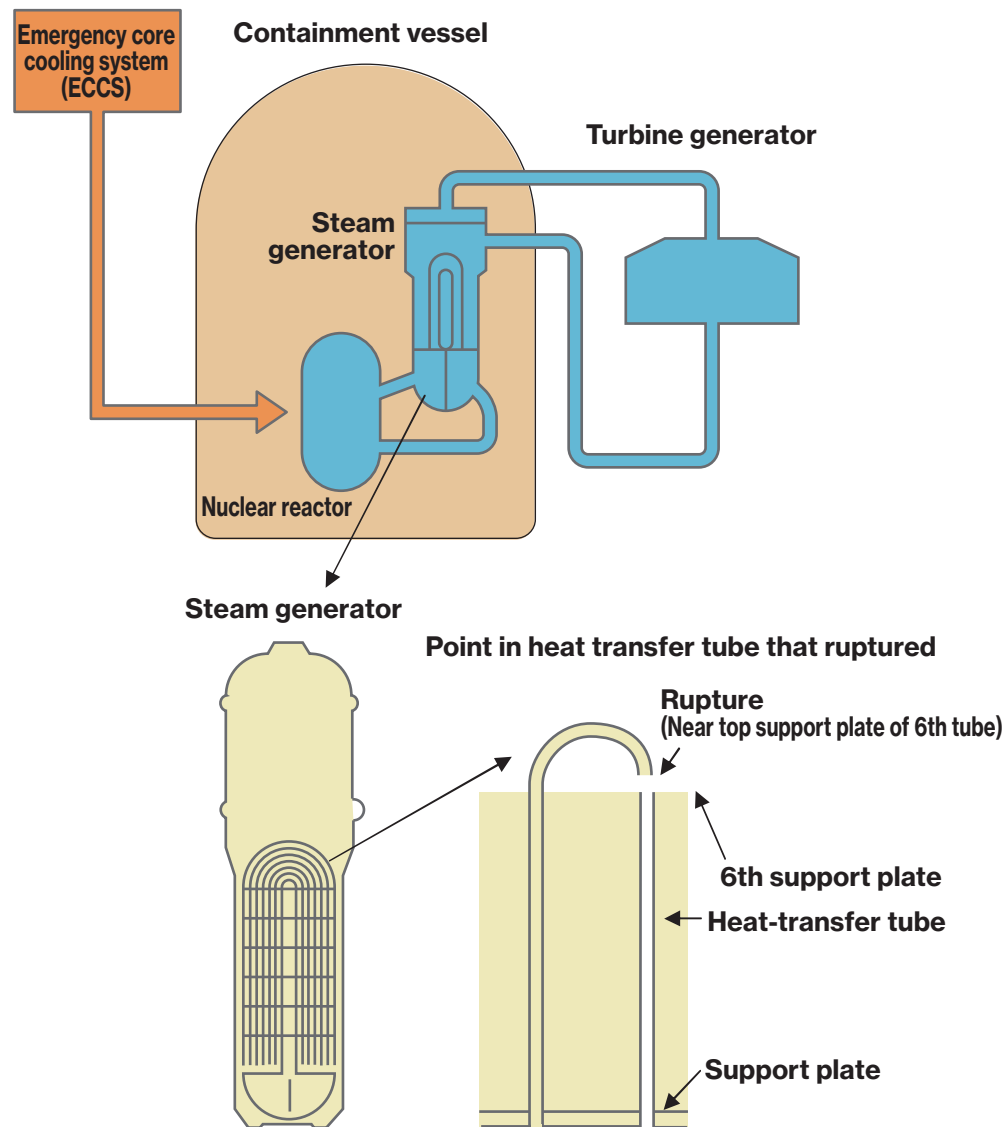
On February 9th, 1991, one heat-transfer tube on Unit 2 of Kansai Electric Power's Mihama Nuclear Power Plant ruptured, initiating automatic shutdown of the reactor and activating the Emergency Core Cooling System (ECCS).

The results of the ensuing investigation showed that a fixture designed to suppress vibration to the heat-transfer tube had not been inserted as far it was designed to be, resulting in abnormal vibrations of the tube.

As a result, it was found that this high cycle fatigue (force repeated over 100,000 times) led to the material not being able to withstand the force, and the pipe rupturing.
